Visual inspection of bearing can establish probable cause of damage

Drying cylinder bearing damage: case 1

PUB 11147/26 EN · August 2019

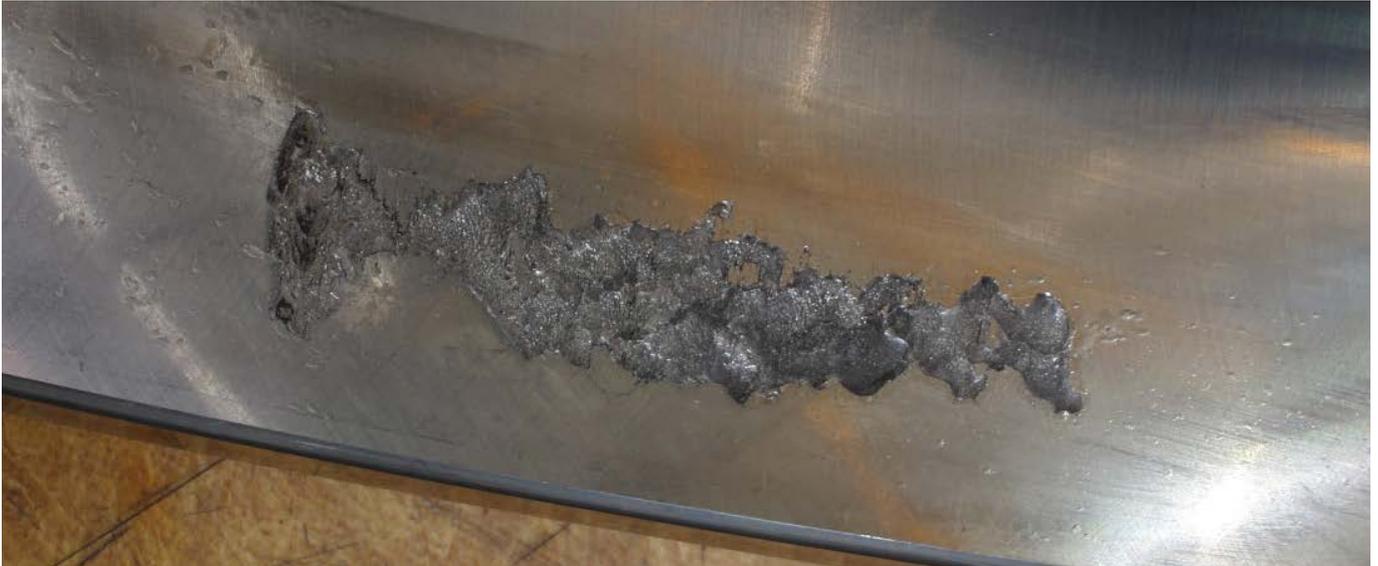
Fig. 1: Bearing damage that doesn't require laboratory analysis.

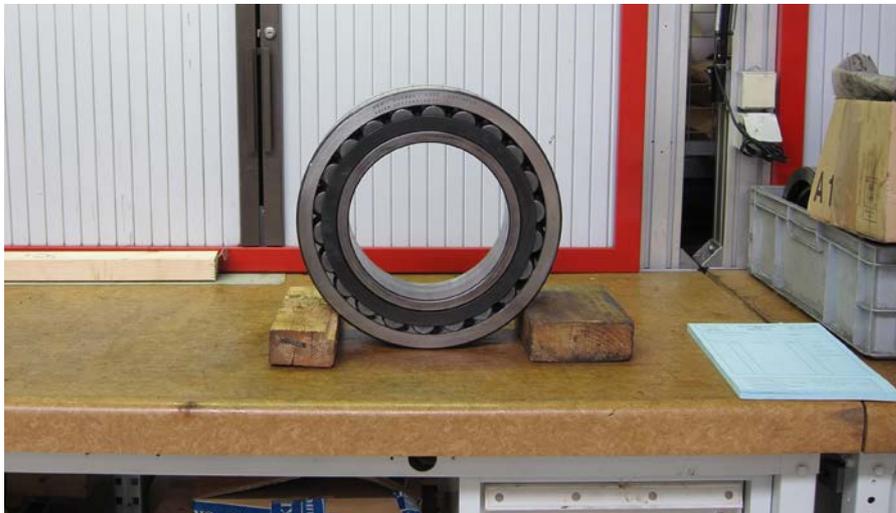
Fig. 2: Complete bearing in quite good condition, ready for investigation.

One year later, the mill sent me a damaged bearing, treating it like a new bearing to avoid causing additional damage that could be misleading. This provided the chance to receive a complete bearing that seemed to be in quite good condition (→ fig 2).

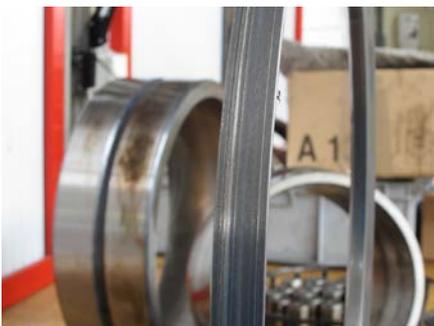
With the exception of the outer diameter (→ **fig 13**), where some slight wear is visible on one side and on the contact between the guide ring and half cage, the guide ring is in very good condition (→ **fig 14**). There is no smearing, and only very slight abrasive wear.

Fig. 13: Outer diameter of guide ring: slight wear.

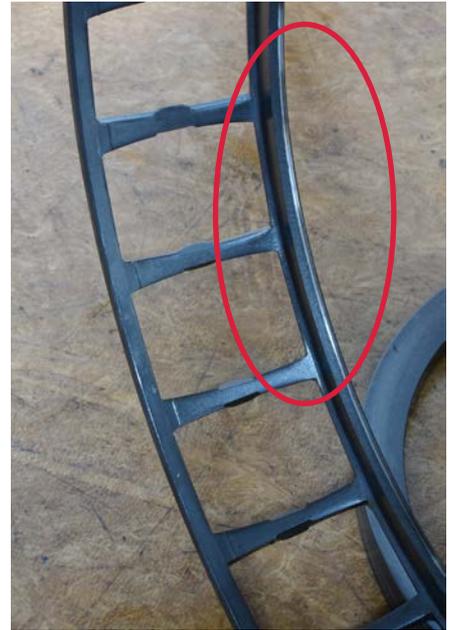
The very first action is to check whether the half cages have signs of wear – in the drying cylinder application, this would point to a lubrication issue. Visual inspection shows very slight abrasive wear in the cage pockets where there is contact with the rollers (→ **fig 15, 16 and 17**). I cannot feel any sharp edges with my thumb (→ **fig 17**), and there is only slight abrasive wear on one half cage – at the contact with the guide ring (→ **fig 16**), and, on the other guide ring, at the contact with the inner ring (→ **fig 15**). Note that sharp edges and/or burrs are created by a lack of lubrication between the roller and the cage. Of course, there is a risk that you could cut yourself, so you must be as careful as when checking the sharpness of a knife with your finger. Unfortunately, the touch-test is often more effective than the visual inspection. There is no adhesive wear (smearing).

Fig. 15: Half cage with slight abrasive wear at its contact with the inner ring.

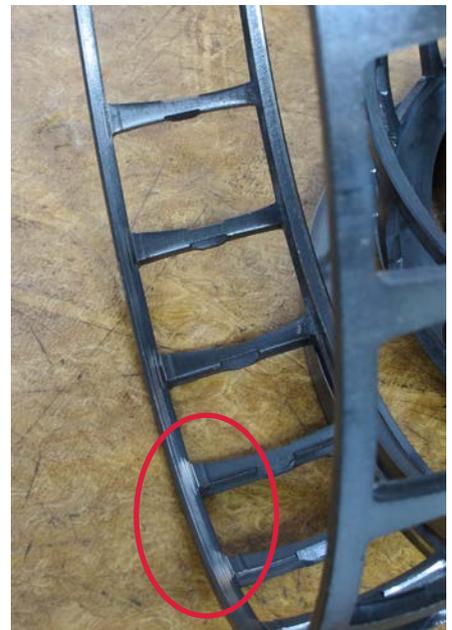
Fig. 16: Half cage with slight abrasive wear at the contact with the guide ring.

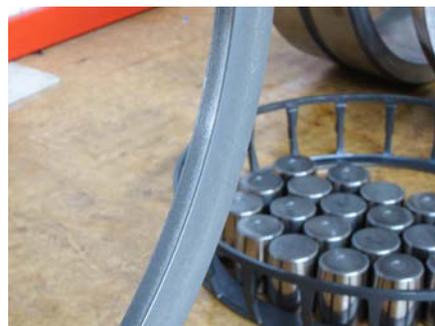
Fig. 14: Face and bore of guide ring: in good condition.

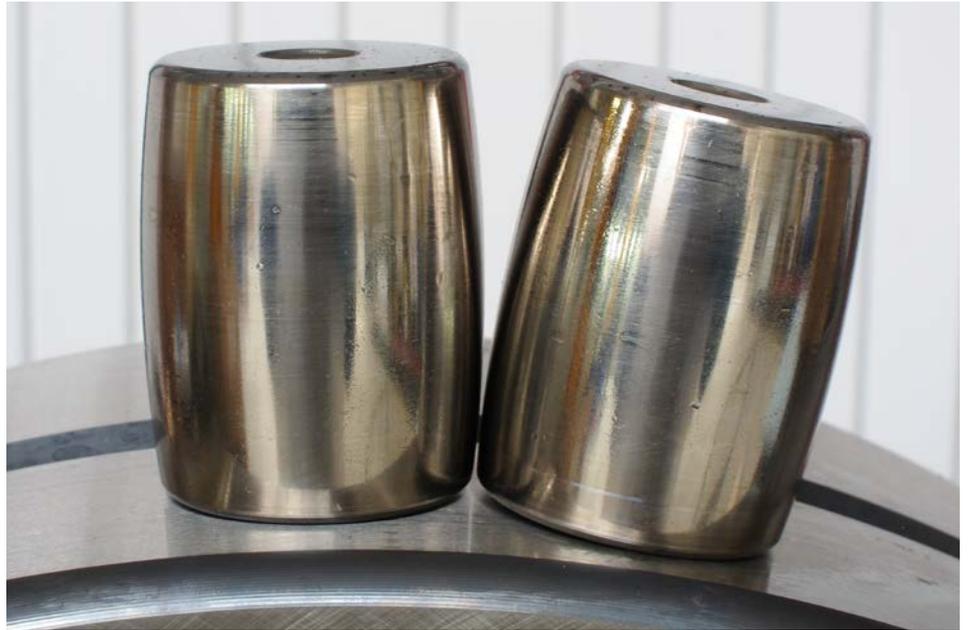
Each roller is visually inspected, revealing that they are in more or less similar condition, with some slight abrasive wear and indentations due to solid hard particles. The rollers on one row have more indentations. Apart from the presence of indentations and some slight circumferential grooves, the rollers are in good condition (→ fig 18).

Fig. 18: : Rollers with slight abrasive wear (shiny appearance) and numerous indentations.

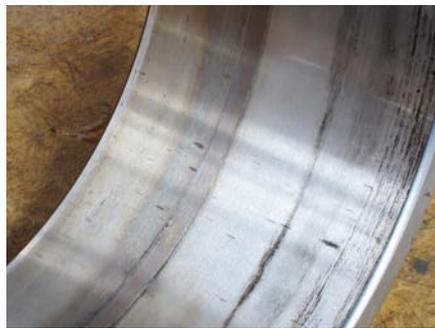
The inner ring bore (→ fig 19) shows some slight fretting corrosion. The shape suggests a slight lack of a tight fit, and perhaps conicity and straightness deviation in the contact, but nothing serious. Small axial smearing marks suggest that the bearing mounting has been performed without oil or with too thin a coating of oil, or that perhaps some small hard particles became trapped between the inner ring and shaft. A reminder about best practices for bearing mounting should be sent to the mill, even if this slight damage has no influence on the bearing service life.

Fig. 19: Inner ring bore. Slight fretting corrosion and small axial smearing marks.

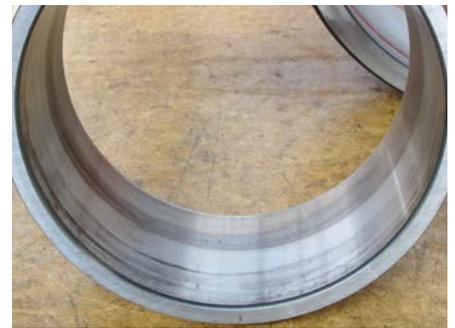
The inner ring faces are in good condition – as good as new for the face on the large bore diameter (→ fig 21), with slight fretting corrosion on the face in contact with the locking washer and locking nut (→ fig 22).

Fig. 21: The condition of the large bore diameter side inner ring face is as good as new.

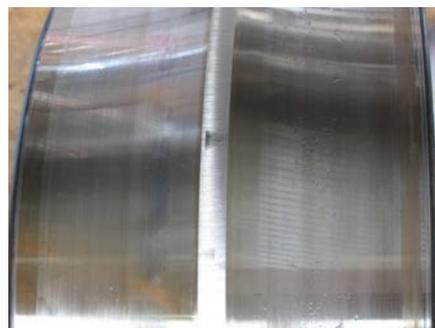
The condition of the inner ring raceways (→ fig 20) is like the roller's condition. What is written above, concerning the rollers, is valid for the raceways and will then not be repeated.

Fig. 20: The condition of the inner ring raceways is like the roller's condition.

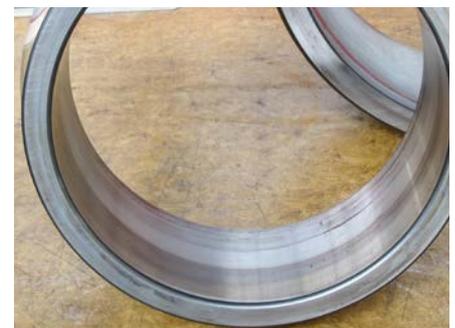
Fig. 22: Small bore diameter side: slight fretting corrosion.

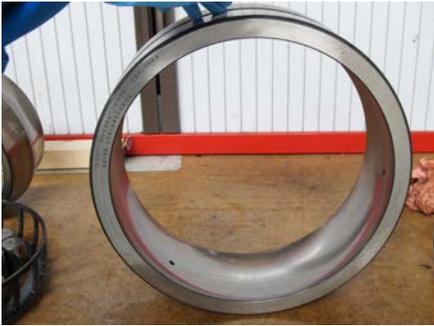
The condition of the outer ring faces
(→ fig 23 and 24) is as good as new.

Fig. 23: Outer ring face, designation side, is in good condition.

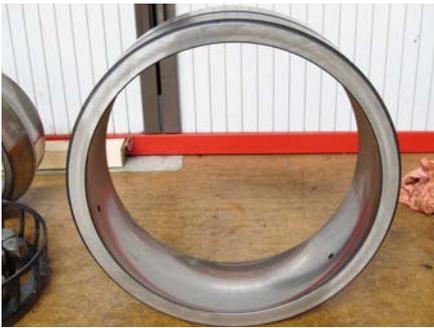
Fig. 24: Outer ring face, opposite designation side, is in good condition.

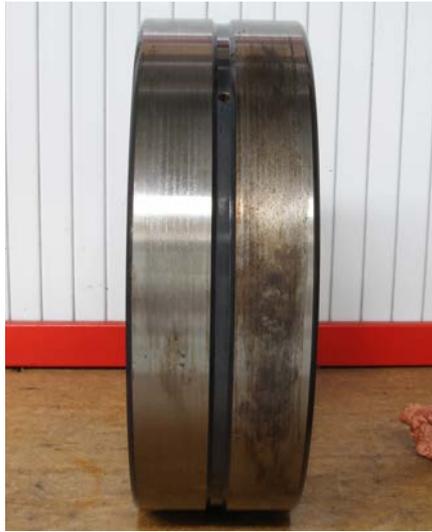
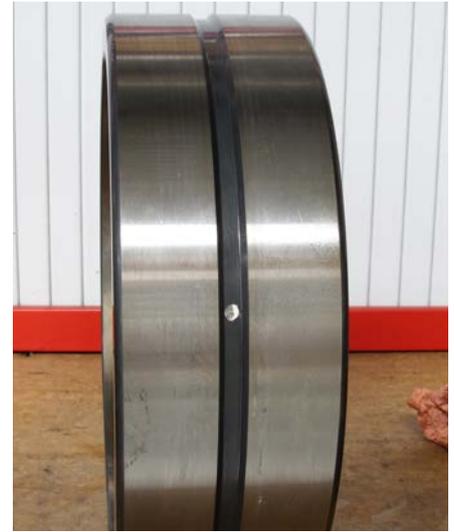
Fig. 25:

The outer diameter has some fretting corrosion in the loaded zone – this is only slight on one side, but more pronounced on the side that has its raceway with the spall (→ fig 25). In the unloaded zone area (→ fig 26), the outer diameter is in quite good condition. With a loose fit, fretting corrosion cannot be avoided (read Pulp & Paper Practices, issue 16). The intensity of the fretting corrosion depends on many parameters, including load and raceway condition. Is the greater fretting corrosion on one side due to axial load (one row with greater load than the other) and the spall, which increases the fretting corrosion damage? This is possible, but it cannot be confirmed by the spall alone. It is too early to conclude that it is the high axial load, and that the spall is premature fatigue due to the excessive axial load. Such hasty conclusions should be avoided.

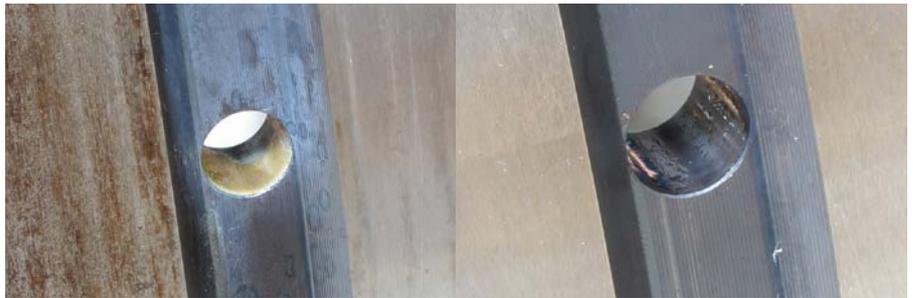
Fig. 27:

Staying with the outer diameter, it is noticed that one of the lubrication holes in the outer ring has some mayonnaise-like substance (→ fig 27), whilst the others are clean.

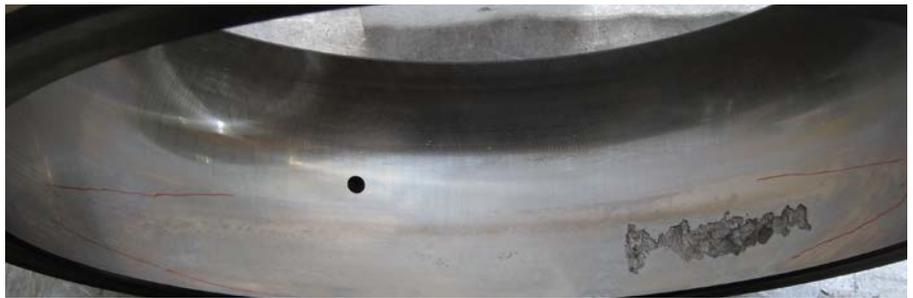
Fig. 28:

With the exception of the spall and the indentations, the outer ring raceways (→ fig 28) look to be in good condition. The grinding pattern from manufacturing can still be seen even in the most loaded zone, and the lubrication is fine. The length of load zone on each raceway is checked to confirm or eliminate the possibility of a heavy axial load. But, as the lubrication is good, it is difficult to be 100% sure where the load zone starts and ends on the raceway which doesn't have the spall. Depending on the light, it appears that the load zone, which doesn't have the spall,

is smaller, confirming a higher load on the raceway which has the spall, meaning that this last raceway takes some axial load in addition to the radial load.

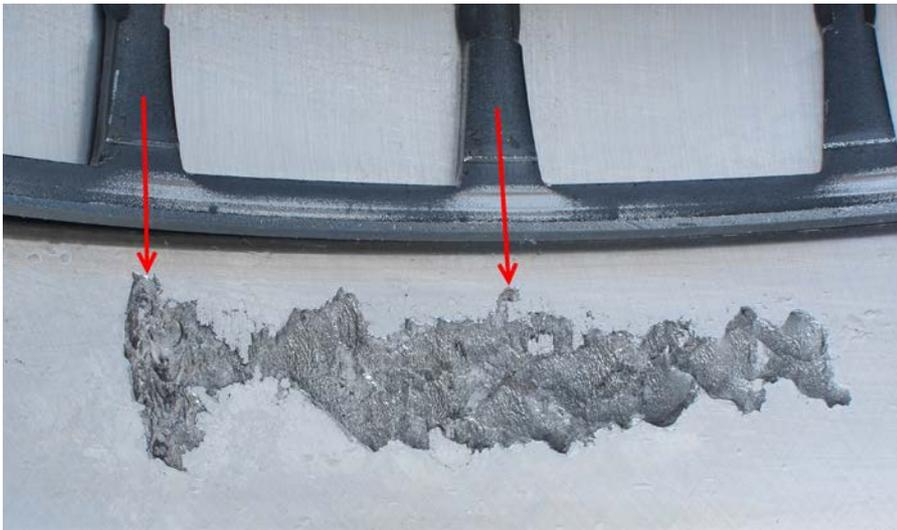
Fig. 29: Spall on the outer ring raceway (cage) can help to discover evidence about damage sustained during standstill.

By placing the cage close to the raceway damage (→ **fig 29**), I can look for clues indicating possible standstill damage, with the main damage being separated by the distance between two rollers. The red arrows show two areas where the primary damage, before the spall, could have occurred.

Note that the right-hand arrow (→ **fig 29**) points to a sort of hook, where sub-surface crack propagation seems to be axial. Another question: position of primary damage? Perhaps, or not.

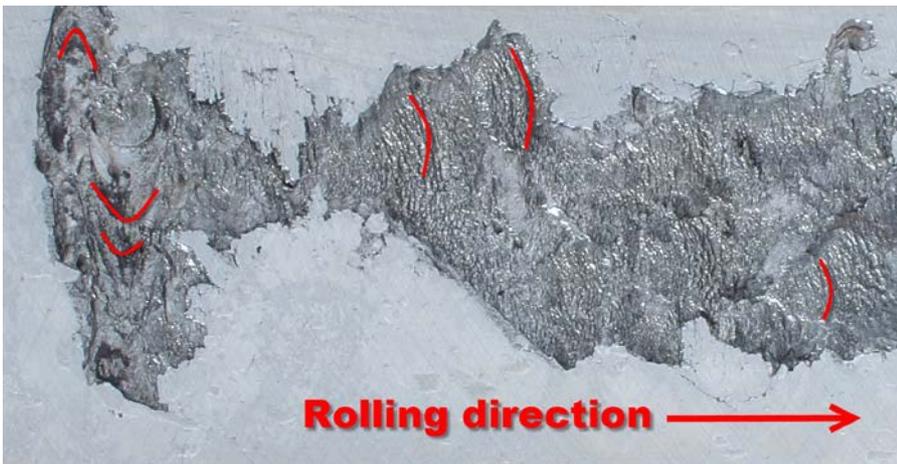
Fig. 30: Primary propagation of the fatigue is in the axial direction, and then in the rolling direction.

It is **Fig 30** that reveals some clues. Normally, on such bearing types, spall created by subsurface fatigue develops in the rolling direction, and not so much in the axial direction. The spall shape shows propagation of the spall from left to right, except for on the far left, where crack propagation is in the axial direction. It is typical in spherical roller bearing failure cases where there has been axial initial raceway damage that the sub-surface microcracks first develop from the damaged area in the axial direction, and subsequently go on to develop in the rolling direction.

The main cause of the bearing damage cannot be identified by the visual inspection alone. All we know is that the most probable cause is damage at the roller and raceway contact during standstill – please note that I didn't write "the cause" but "the most probable cause".

Performing corrective actions, including improved water removal from oil by the lubricating system, in order to reduce water content, will stop repetitive bearing failures due to standstill corrosion. However, this will be the case for new bearings mounted after the corrective actions. But you should expect some more bearing failures for those still in service that have previously had contact with free water.

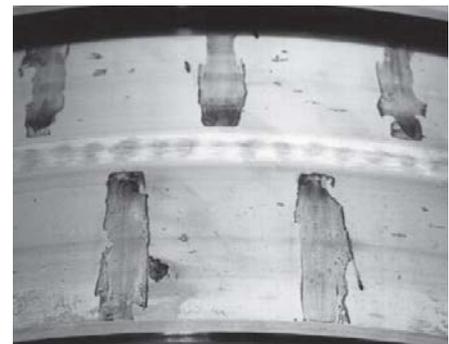
"Fig 32 shows corrosion on the inner ring of a spherical roller bearing under static conditions. The corrosion marks are separated by the same distance that separates two adjacent rollers. There is enough water in the lubricant to cause contact corrosion marks, but not enough to significantly corrode the other parts of the raceways that are protected by the lubricant."

Fig. 32: Standstill corrosion under static conditions.

For the bearing shown in Fig 32, the corrosion marks that are only superficial can be easily worn away. Only the deepest corrosion marks will remain as weak spots, and it is from these that fatigue microcracks will develop, resulting in a spall.
