Visual inspection of bearing can establish probable cause of damage

Drying cylinder bearing damage: case 1

PUB 11147/26 EN · August 2019

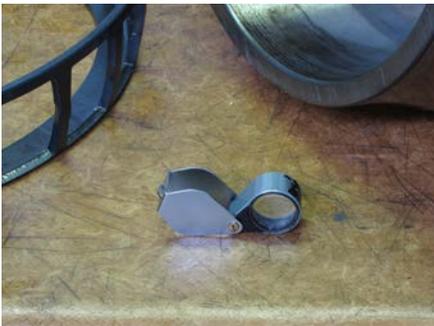
Fig. 12: The must-have tool: an 8 to 10 times magnifier.

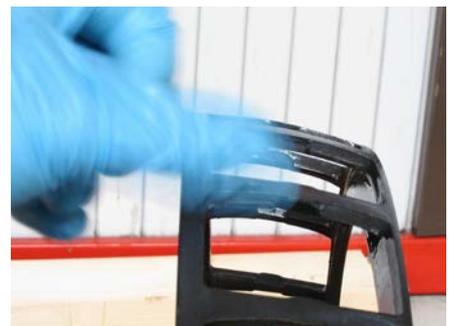
The very first action is to check whether the half cages have signs of wear – in the drying cylinder application, this would point to a lubrication issue. Visual inspection shows very slight abrasive wear in the cage pockets where there is contact with the rollers (→ **fig 15, 16 and 17**). I cannot feel any sharp edges with my thumb (→ **fig 17**), and there is only slight abrasive wear on one half cage – at the contact with the guide ring (→ **fig 16**), and, on the other guide ring, at the contact with the inner ring (→ **fig 15**). Note that sharp edges and/or burrs are created by a lack of lubrication between the roller and the cage. Of course, there is a risk that you could cut yourself, so you must be as careful as when checking the sharpness of a knife with your finger. Unfortunately, the touch-test is often more effective than the visual inspection. There is no adhesive wear (smearing).

Fig. 17: Feeling for sharp edges or/and burrs with the thumb.

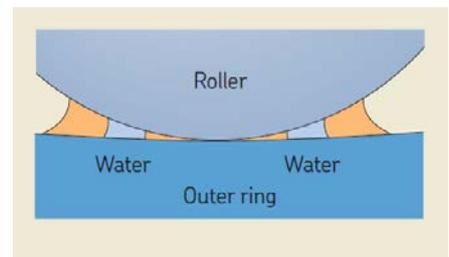
"If a non-rotating bearing has free water in the lubricant, this water will accumulate at the bottom of the bearing. The concentration of the water will be highest at a certain distance from the rolling contact (→ fig 31). The reason for this is that the free water in the oil, being heavier, will sink until it comes to a suitable gap between the roller and the raceway. Corrosion due to water or any other aggressive liquid at, and, around the contact surface between rollers and raceways is called contact corrosion, standstill corrosion or etching.

Fig. 31: Water concentration in a stationary bearing.
