SKF Pulp & Paper Practices

SKF Global Pulp & Paper Segment | No. 21 | August 2017

Better make sure that your bearings are properly lubricated

What to expect from a lubrication system audit

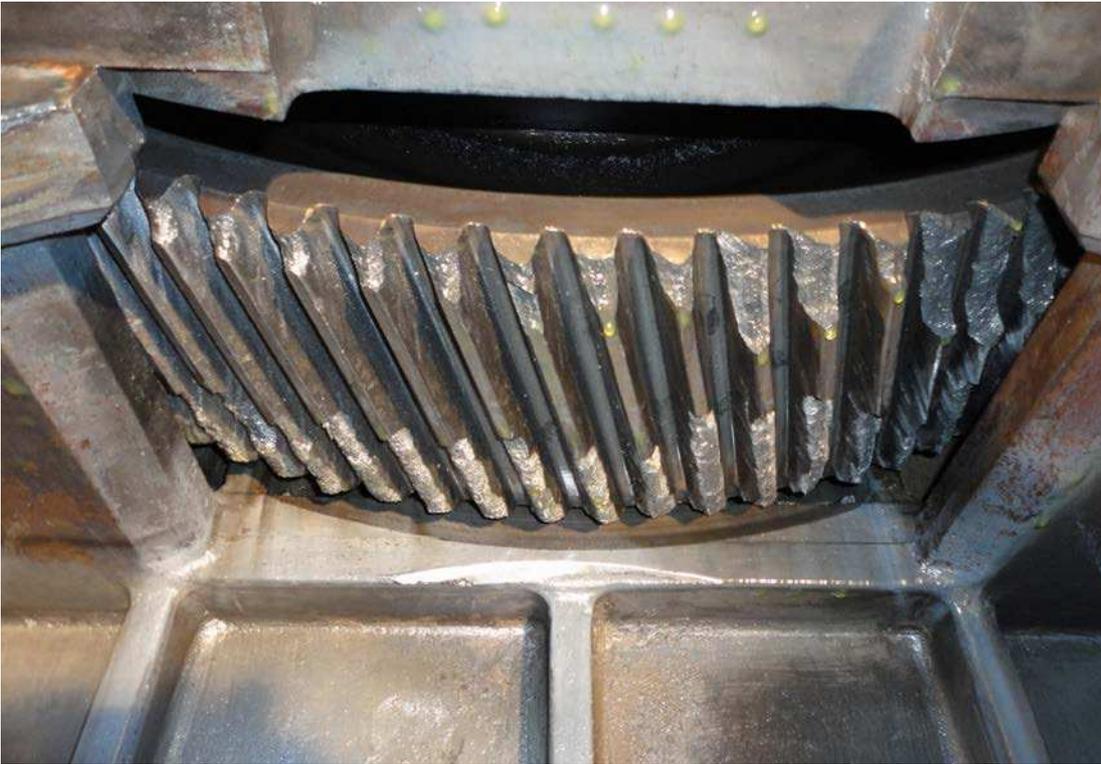
Fig. 1: Heavy wear on gear teeth

This machine's drive side gearing was designed so it had a lubrication point at the top dryer gear and another at the bottom where the bottom dryer gear and the transfer gears mesh. The mill had shut off the flow to all the lower gear nips. We can only assume their thoughts were that the oil to the top gear would run down to all the other gears. Each gear nip lubrication point should have been getting 1,75 litres per minute of oil.

The oil requirements for these 70 new points they added turned out to be 110 litres per minute. When that additional flow was required, the oil system could not supply it at the pressure needed to satisfy the system's pressure requirements. The mill's solution at the time was to take away oil flow going to all the bottom dryer gears. After shutting off approximately 90 litres of oil to those gears the oil system worked again. They could make paper and everyone was happy until the gears began to wear out prematurely (see **figure 1**).

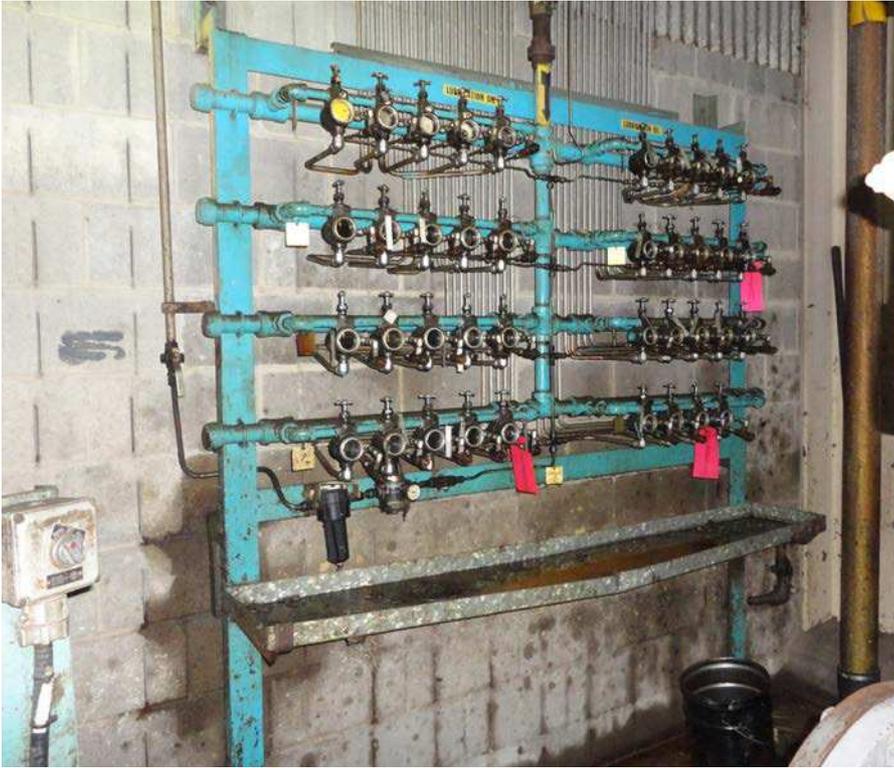
Fig. 2: Old sight glasses for monitoring oil flow on older machines. Sometimes still found during audits, they often leak badly, hence the collection pan. Much better flow monitoring, alarming and trending technology is available today from SKF

We count and gather information on all existing oil flow meters and compare that number to the number of lubrication points we understand the machine has. Sometimes we will find meters shut off, missing or recently added. If we find more active meters than we appear to have bearings and gears, we must find out what those meters service. We inspect the condition and if possible the accuracy of the existing oil flow meters. We look closely at how the flow meters are mounted around the machine and where they are mounted (see **figure 2**). A system can sometimes be improved or made safer

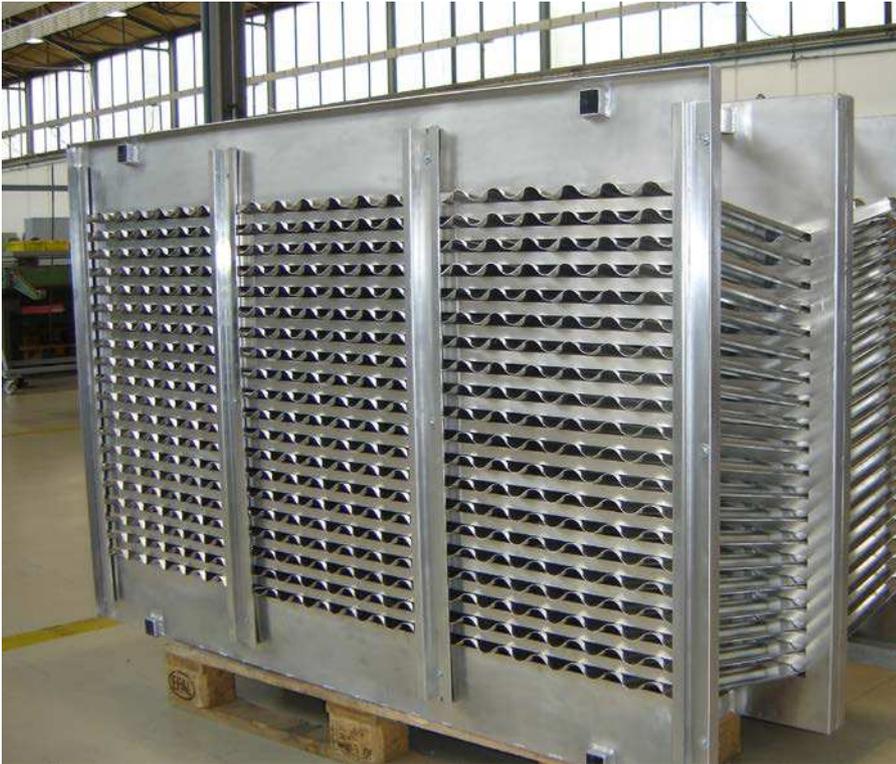
Fig. 3: Example of the internal plate separators found in some new SKF oil reservoirs to improve water and air removal

It is important to gather information about the existing oil reservoir(s). Normally we do not get to inspect the internals so finding drawings or past inspection reports can be very helpful. If we can, we will open the inspection covers and note the condition of the parts above the oil level. We measure their size so we can calculate the working volume they will hold. If they are old and have no special internal features, we can compare them to the old TAPPI standards that were used for so many years. We now know that those standards can be much improved with new reservoir technology (see **figure 3**).

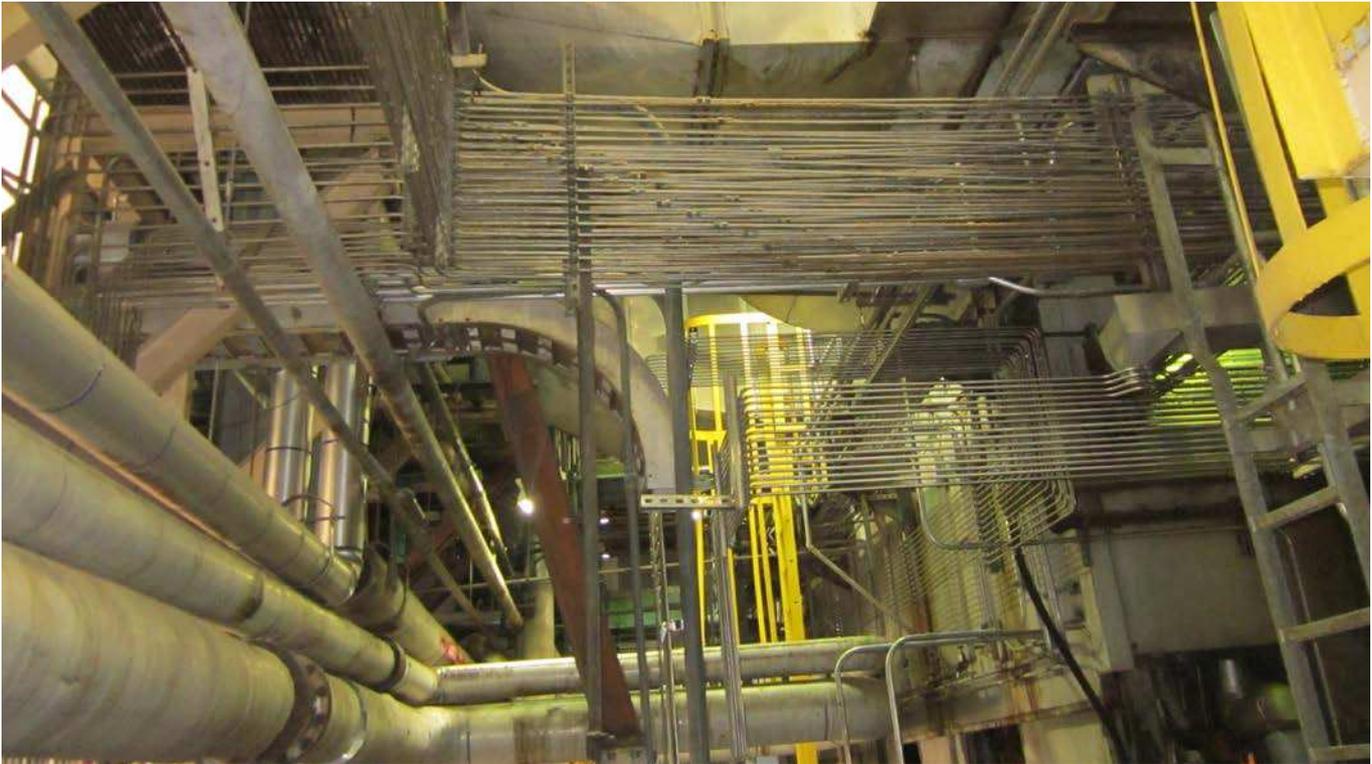
Fig. 4: Example of overly long tubing lengths between flow meters and lubrication points

Tubing is typically used between the oil flow meters and the lubrication points. This is inspected for material of construction, size, and external condition. We inspect for signs of stress corrosion cracking where possible and we check the length of average tubes and how well they are installed (see **figure 4**). The size of the supply tubing is important to understand what the operating pressure of an oil system needs to be. If we have to recommend higher oil flows for a machine we may have to report that the system's operating oil pressure must be increased or the size of the supply tubes might have to be larger, or both of these might have to be done.
